Manhole Inspection Summary

Manhole # S06GG2008MH

Location Address: **3513 BONFIELD RD**

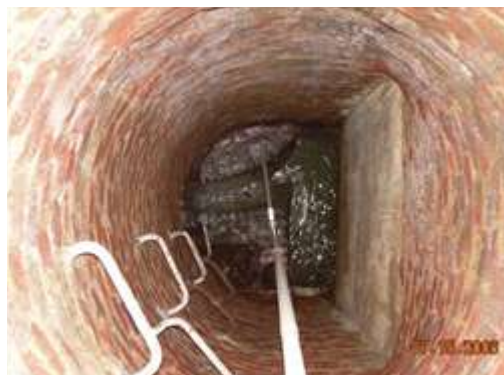
Top View

Adjustment, Corbel and Barrel infiltration.
Corroded steps. Bench debris.

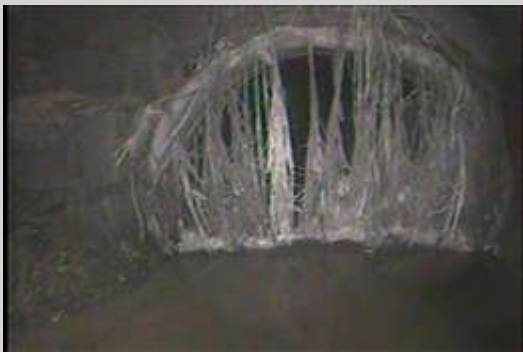
18 in. Circular Gravity Sewer Pipe Out @ 12 O'Clock

Barrel and Channel root intrusion.

Infiltration: **Evidence** Pipe Seal Cond: **Roots**

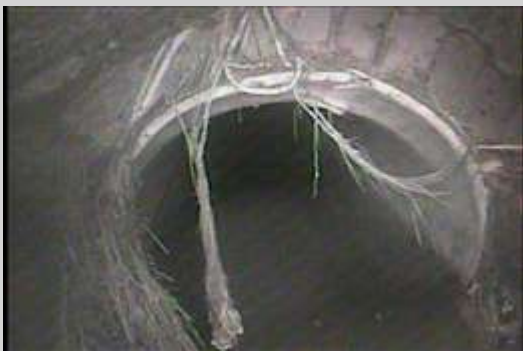
18 in. Circular Gravity Sewer Pipe In @ 6 O'Clock

Infiltration: **Evidence** Pipe Seal Cond: **Roots**

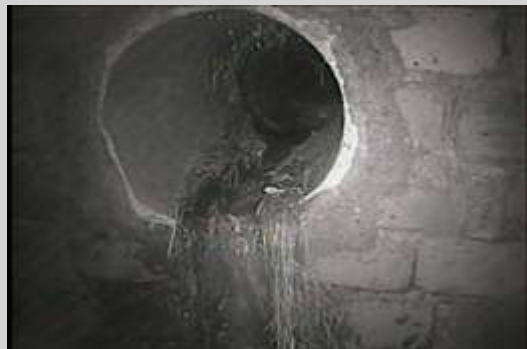
8 in. Circular Gravity Sewer

Root intrusion and Circumferential cracks.

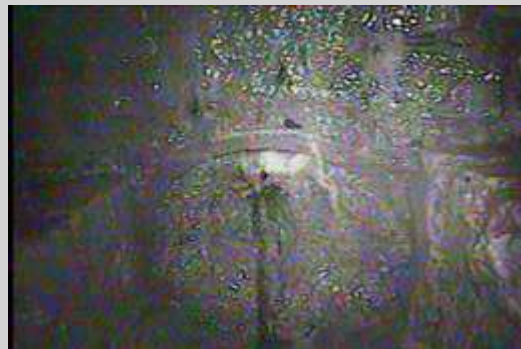
Drop In @ 9 O'Clock

Comments **The I9 "Drop" is appears to be completly clogged.**

Deposits: ☐ None ☐ Mud ☐ Sludge ☒ **Debris** ☐ Grease

Deposits Extent: **Heavy**

Drop Condition: **Partly Clogged**
